Many of our members may not be aware of what happens when a cam drive belt lets go - the following photos are from a recent failure on my 4WD diesel engine due to a diesel engine service centre not taking due care when reinstalling a drive belt after overhauling the fuel injection pump. The major damage included a broken camshaft, 6 bent valves, 6 bent/indented adjusting shims and fortunately only one piston crown indented from hitting a valve which did not require replacement. The belt broke at a speed of 110Km/hr [70mph] about 120Km [75 miles] from home at 8pm necessitating a trip home on the back of a flat-top truck after a 2 hour wait for it to come from Taree.

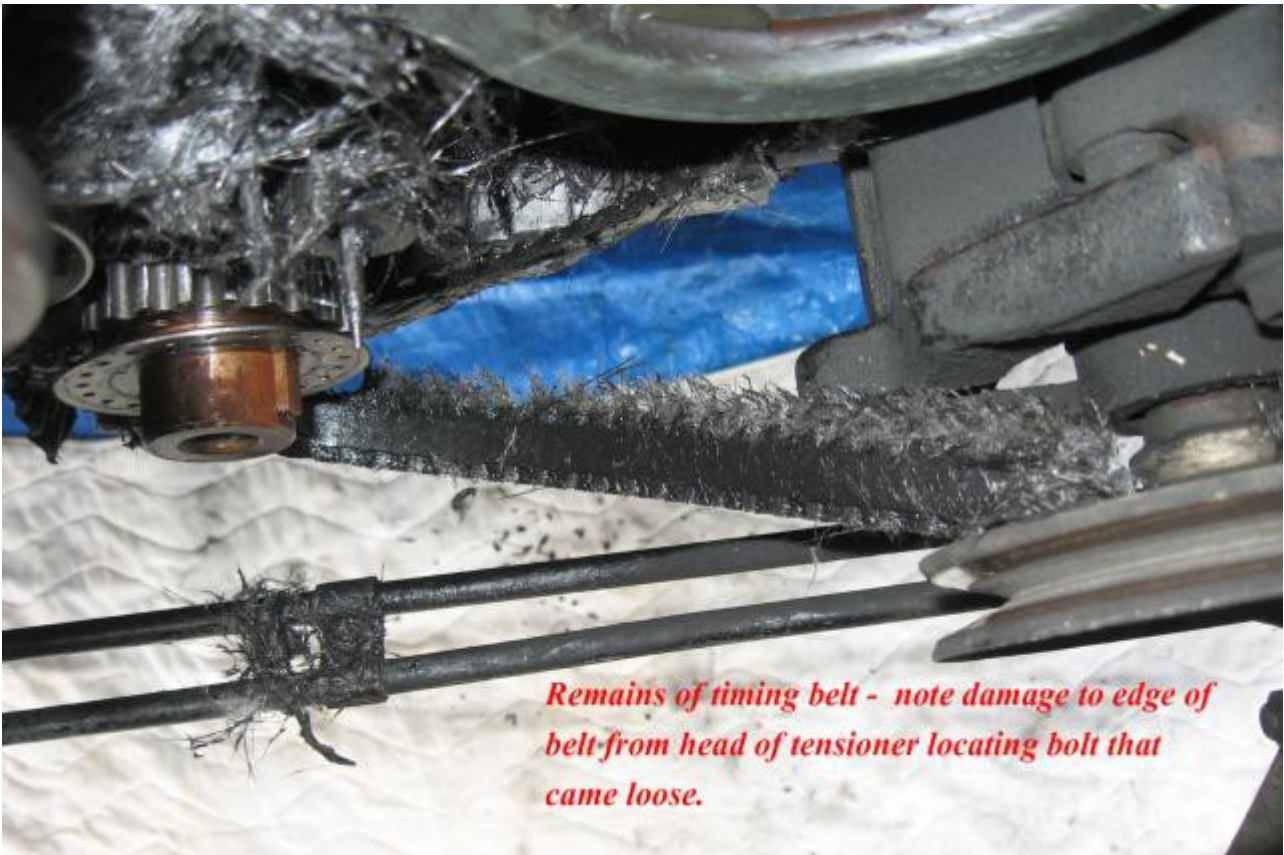
This is what I found when I removed the front cover of the timing case. The bolt was in the bottom of the case not as shown here.

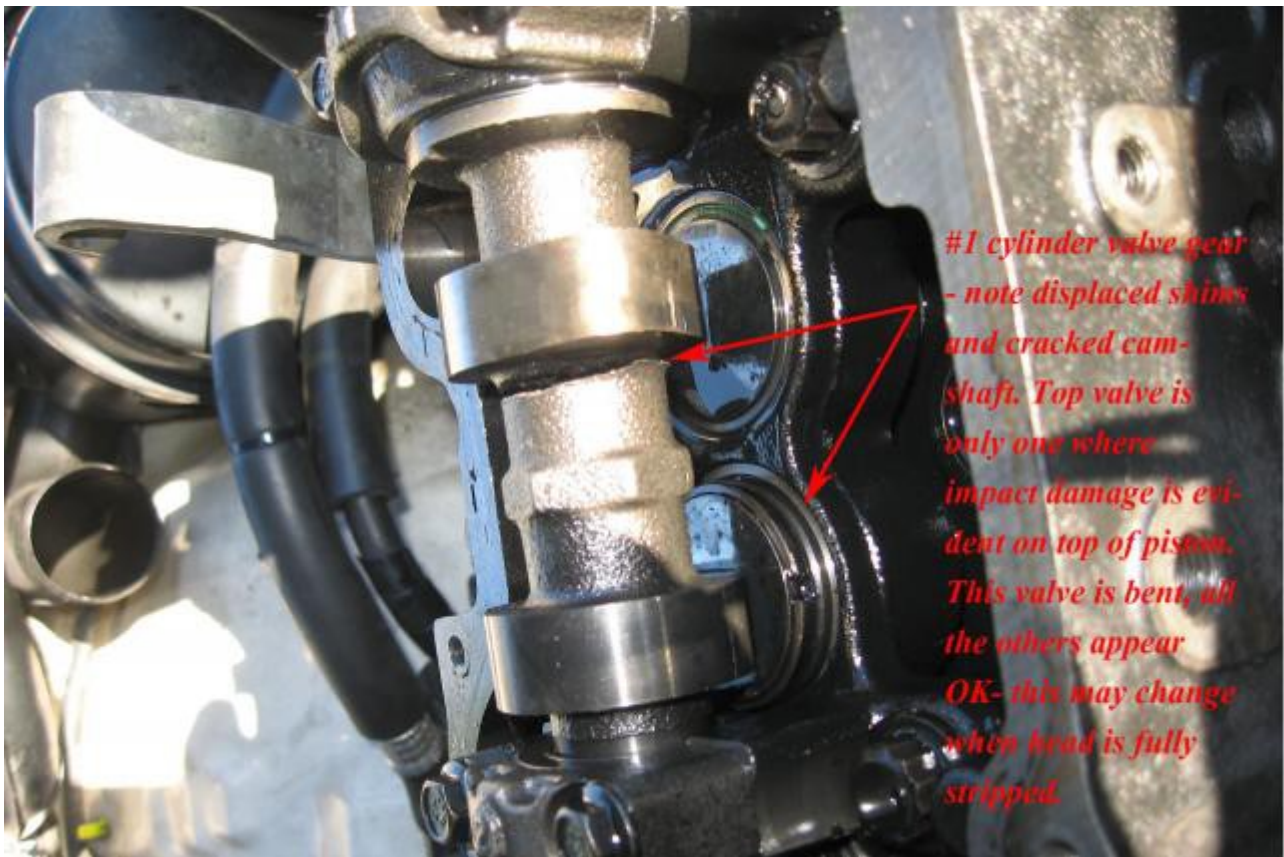
Cracked camshaft above #1 cylinder.

*#1 cylinder valve gear
- note displaced shims
and cracked cam-
shaft. Top valve is
only one where
impact damage is evi-
dent on top of piston.
This valve is bent, all
the others appear
OK- this may change
when head is fully
stripped.*
