The Single Throw Window Winder

by Chris Gillings (NSW)

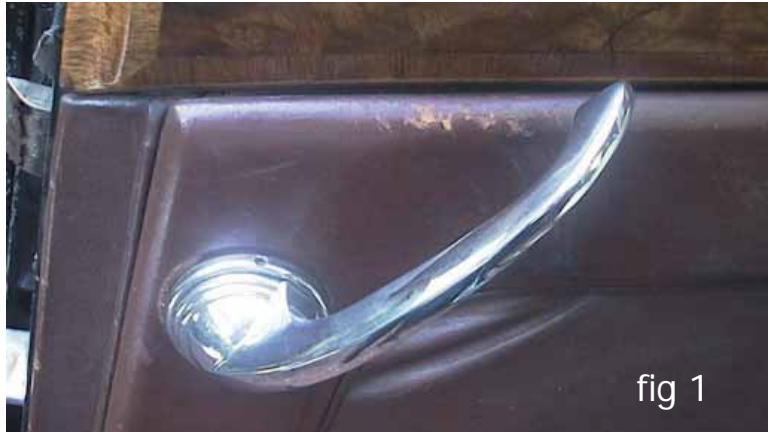
fig 1

Remove the single-throw handle by unscrewing its centre screw. The handle slides off with a bit of jiggling. The door opening handle is held on by the large inner ring (Figure 1). If you don't have the appropriate tool (and I don't) you can loosen the ring with adjustable pliers; but be very careful of the chrome finish. Chamois over the teeth might help. Once it's loose it can be unscrewed by hand until the handle slides out (Figure 2). It's a close thread so it takes quite a few turns.

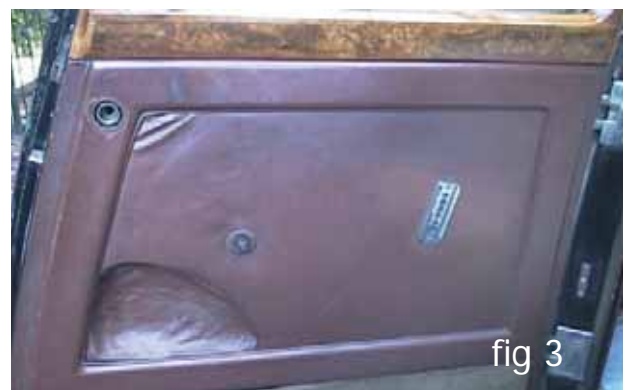
fig 3

need to remove (Figure 3). Unscrew the bolts, taking care not to lose the spacer tubes (Figure 4).

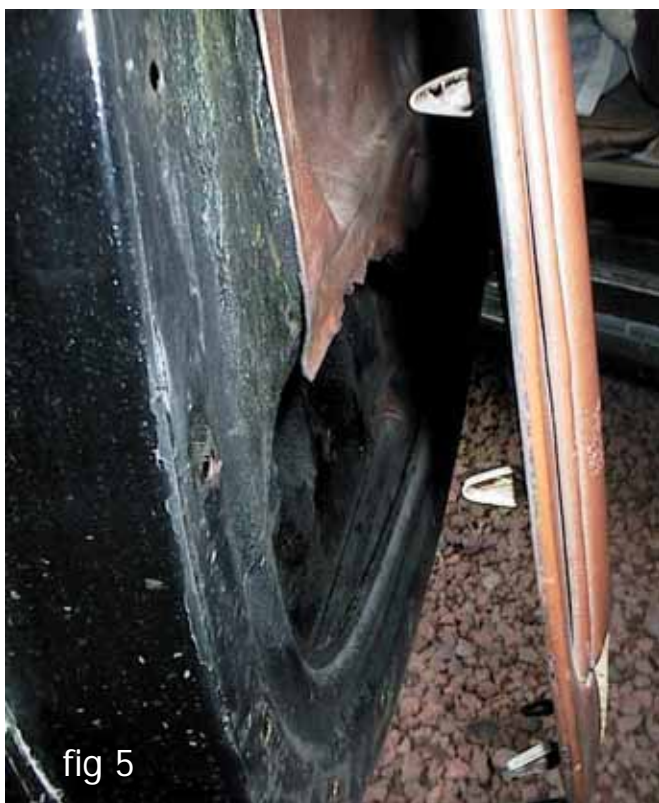
fig 5

Starting on the lower front of the door, slide a large flat bladed screwdriver between the door and trim and pop the clips out (Figure 5). Carefully work upward and around to the wooden door cap. Pull the trim out and down to release it from under the door cap. Figure 6 shows the door free of its skin. The single-throw mechanism is the large unit in the middle.

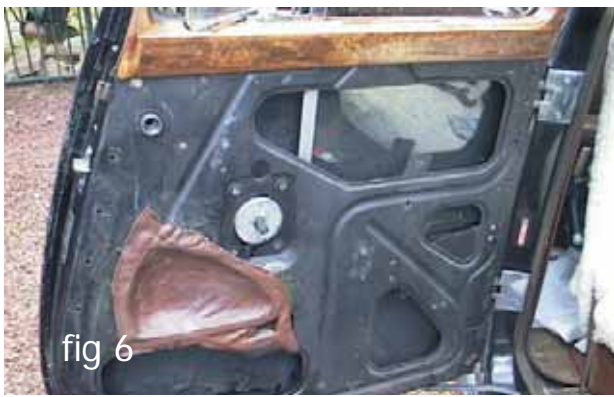
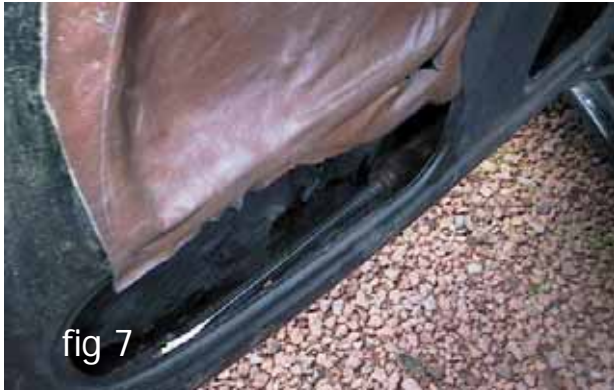
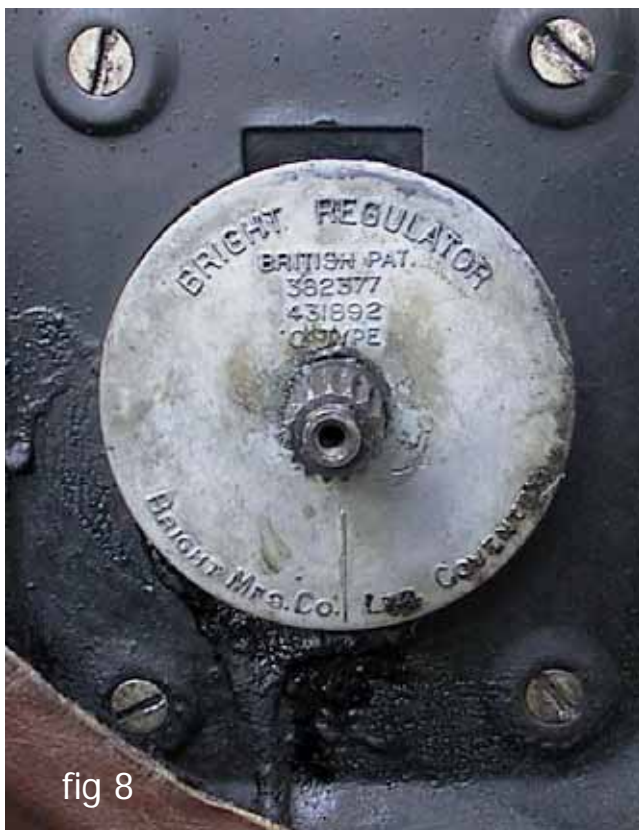
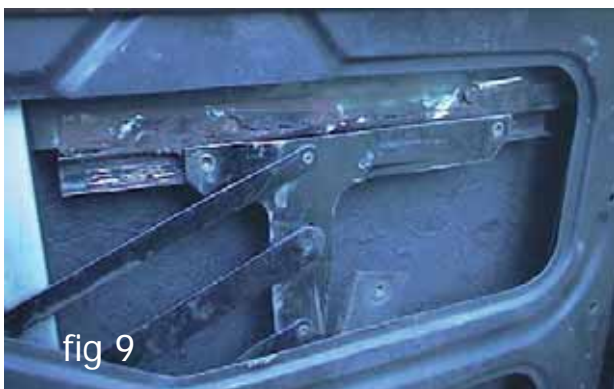
Slide the arm rest up and out by using the adjusting lever underneath. The armrest mount is the last fitting we

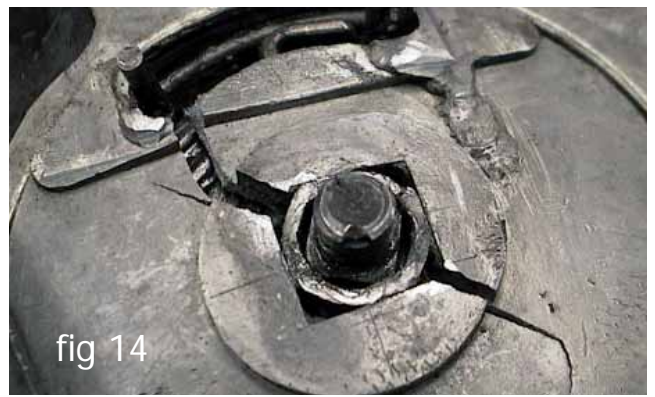
fig 14

arm, all was revealed (Figure 13). The back plate had completely fractured as a result of the pressures exerted by the square centre shaft. There was a square bush between the plate and the shaft - now more or less circular (Figs. 14-16)

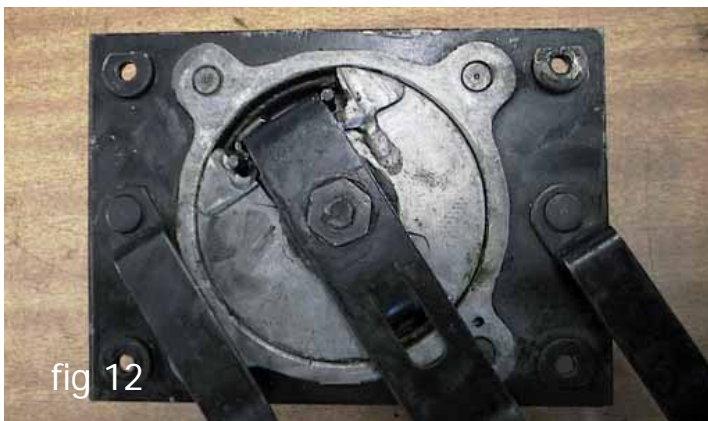
fig 12

The winder as removed is shown in Figure 10 and the reverse in Figure 11. On closer inspection the first thing I noted was the welding on the die-cast back plate (Figure 12). It's obviously been repaired before, perhaps by my screwdriver-misplacing predecessor.

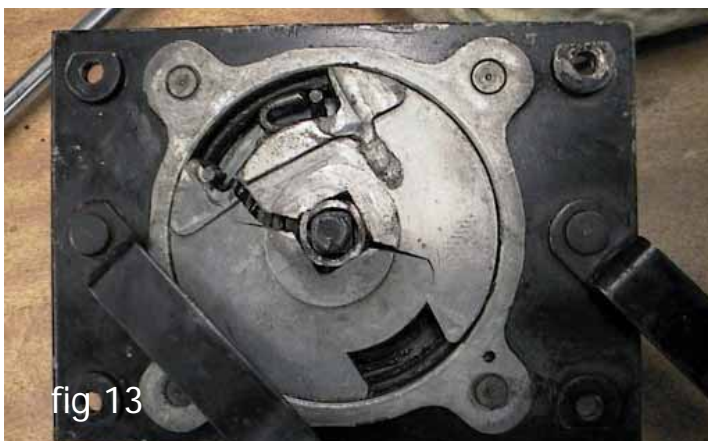
fig 13

Upon removing the nut from the centre bolt and lifting the centre

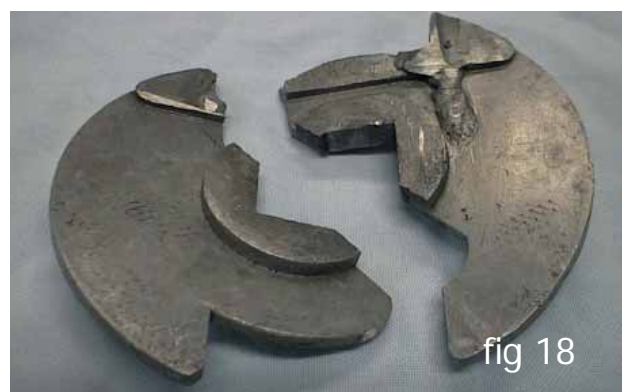
fig 18

After a bit of fiddling with the plate, with a vague thought of repairing it, the fracture completed and the plate fell into two pieces (Figure 18). Finding a replacement part was not an option, especially on a Saturday afternoon, so I called on Barrie to ask him to help me fabricate one.

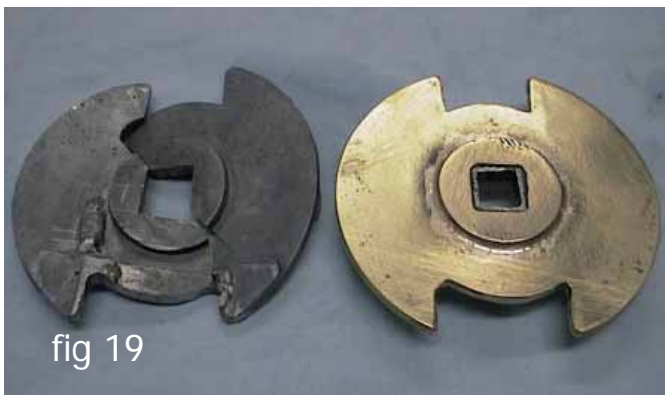
fig 19

For the centre reinforcing mound we machined off a 2.5mm thick disc from some 20mm brass stock and silver-soldered it in place using an oxy-acetylene torch. The plate was now the same thickness in the centre as the original, but thicker elsewhere (Figure 19). The two inside tags were hand cut and shaped and also silver-soldered in place (Figure 20).

We took some 3.2mm (1/8") brass plate, traced the outline of the original and cut out a rough circle. We smoothed the circle by hand with a lisher and finished it on a lathe, after drilling a centred hole of the necessary diameter. The cutaways were made by drilling spaced holes along the cutting line, bending and snapping off the waste and finishing by hand with a file.

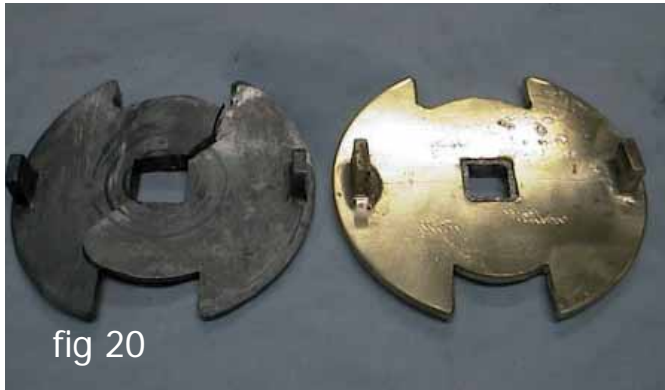
fig 20

The whole fabrication operation took no more than three hours. It would have been quicker if Barrie had not insisted on lecturing me on the use of the lathe, oxy torch and other devices as we went along. As we have done in the past in honour of a job well done together, we inscribed the part appropriately (Figure 20). We're confident that this new part will last for many years to come.

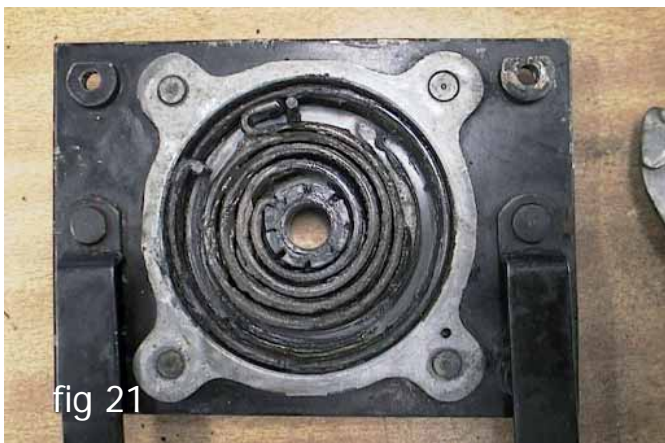
fig 21

The mechanism of the winder is very simple, though I am not entirely sure of the function of the outer spring (Figure 21), except perhaps as a drag to slow the action. The inner spring holds light

tension when the window is up/closed and gains tension when lowered. This makes raising the glass easier, as one would expect. It also makes reassembly easier (Figures 23, 24) because minimal pre-tensioning is needed (though by the castellations in the centre lug in Figure 21 it is adjustable).

Just to make sure of my theory, I placed the reassembled winder in a vise and tested its operation with a spring scale which measured in Newton meters. For tensioning (window opening) 50 Nm is required at the end of the centre arm, and for releasing (window closing) only 25 Nm, which is more or less what I'd hoped. (If I'd been thinking harder at the time I would have also measured the force required to raise the glass.) Perhaps the purpose of the centre lug slots is to tune the force so it's equal in both directions.
