Post55

Spring 2005

Resolving Brake Light Problems

What's That Stuff on the Bulkhead (Firewall)?

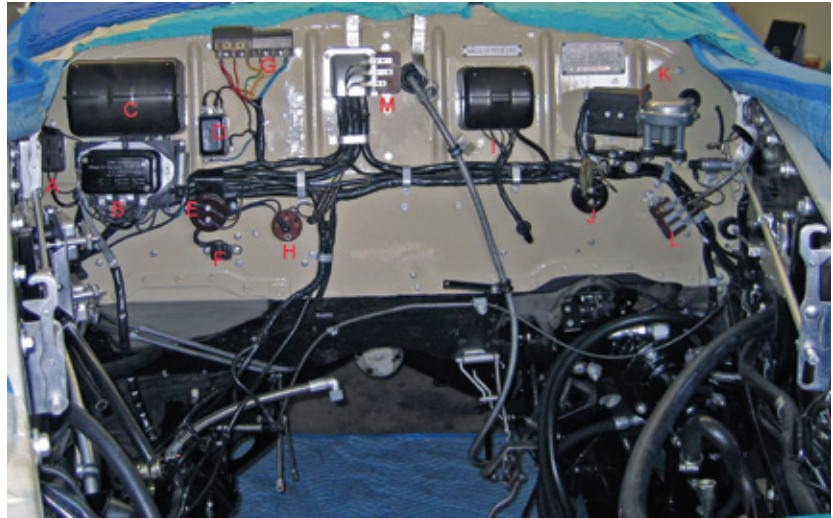
figure 1

Figure 1 is a picture of the repainted bulkhead (firewall). Ralph Curzon, chief judge of the RROC, told me that Savanna Beige is the closest color that he has found and hence the color that I used on the firewall. The underside of the bonnet is painted the same color. Coachbuilt cars may use another color for the underside of the bonnet. Note that the color break (changes from beige to the body color) occurs at the 90-degree bend at the top of the firewall. The body color does not come into the engine compartment.

The items on the firewall are as follow:

- A – horn fuse
- B – voltage regulator
- C – main fuse or distribution box
- D – air conditioning relay
- E – heater rheostat
- F – oiler switch (for choke)
- G – air conditioning rheostat
- H – Scintilla switch (for choke)
- I – electric window fuse or distribution box
- J – heater/demister rheostat
- K – windshield wiper motor
- L – horn relay
- M – headlight flasher relay

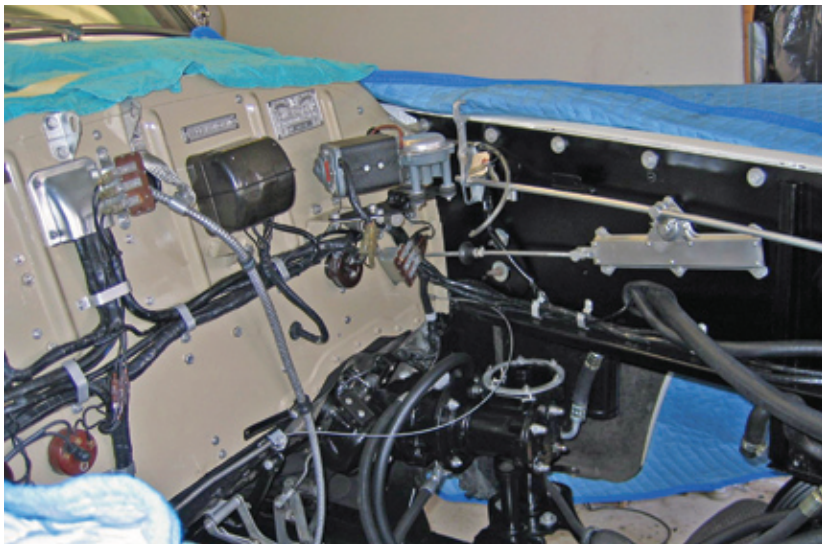
Figures 5 and 6 show an overview of the rear of the left valance and a close-up of the steering box. Figure 7 zooms into the bottom of the steering column to show the two switches that control the reverse light and the

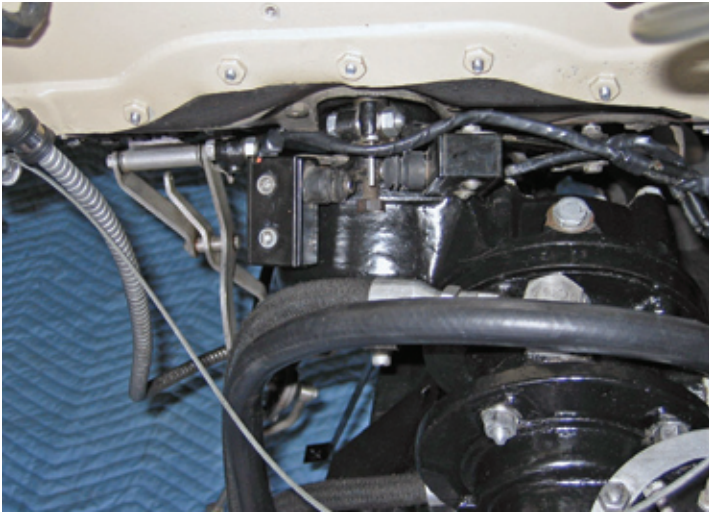
figure 7

switch that only allows the car to be started when the gearshift is in the neutral position.

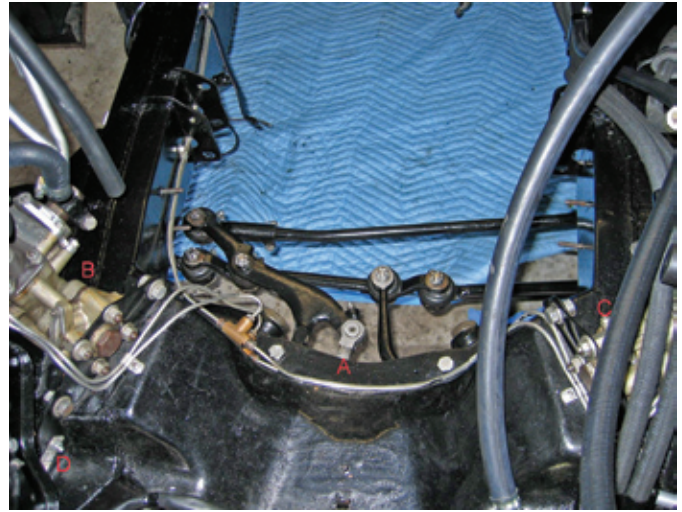
figure 9

Figure 9 is a picture looking from the front of the car into the engine compartment. It allows you to see at A, where the power steering ram connects to the steering linkage. We also see at B and C the front shock absorbers and see the steel brake lines and junctions. In addition, at D, we see the ground strap from the left fender to the chassis. There is a similar ground strap for the right fender. Many cars are missing one or both of these straps or the straps are broken.

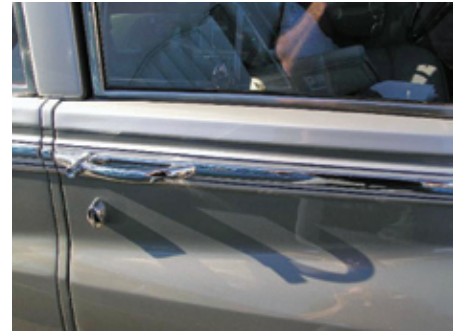
I

- 10 Pinstripes may match the fenders or be a third color. For layout, see photos H, C, I, and J. Regarding color, see Appendix 2.
