# Post55

Summer 2004

# Changing Silentbloc Shock Bushings

# Silver Cloud power steering box leaks and how to repair them.

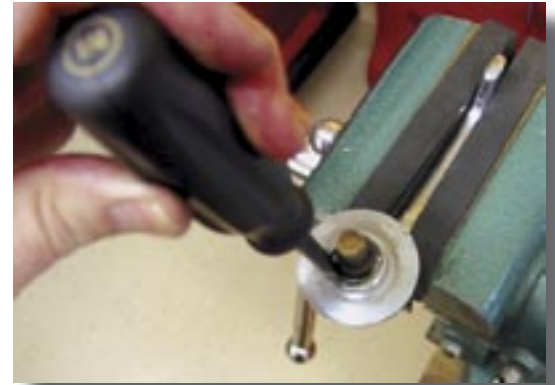
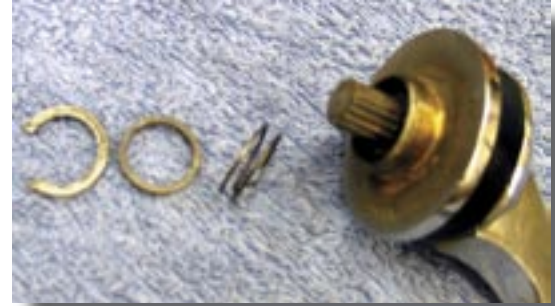
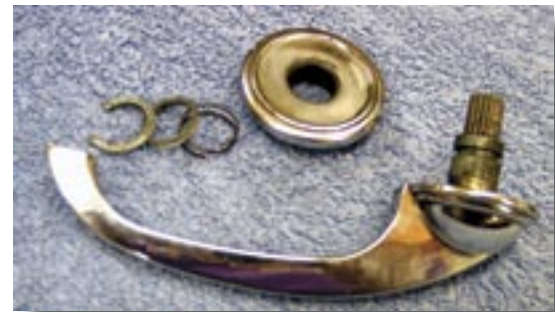
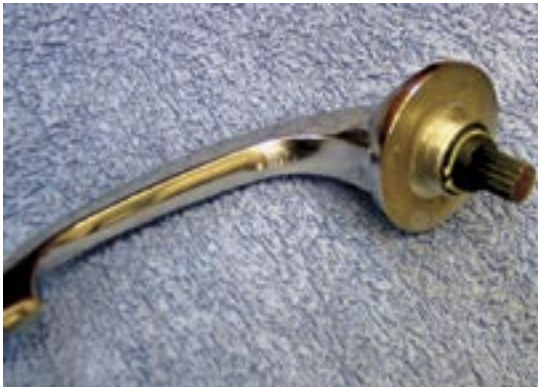
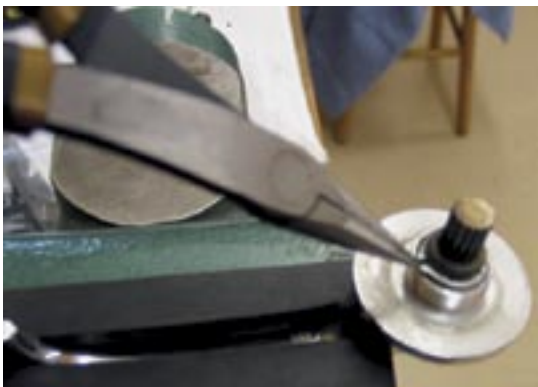
The door handles have usually experienced visible wear, pitting, and scratching from years of use. Should you choose to have them repaired, it will be necessary to disassemble the door handle before chrome plating. Visible in the picture above is the C-shaped retaining ring. I was surprised to find that it was not a snap ring, rather a pliable soft steel ring, easily bent.

Care should be taken not to distort the retaining ring any more than necessary to remove it. By the fourth door handle, I was able to remove it with almost no bending. Once removed, the retaining ring is followed by a spacer/washer and a spring that keeps tension on the assembly.

The backing plate is now free and a decision can be made to plate just the door handle or both the handle and the backing plate. In my case, only the door handles were scarred. I did find what appeared to be molybdenum lubricate between the backing plate and the handle, which seemed to be a good idea if used in moderation.

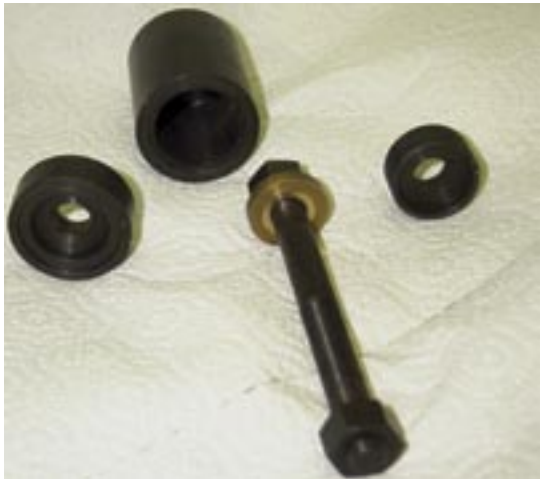
*figure 6*

The bushing in the shock pivot arms can easily be removed and inserted with a standard press. However, the bushings in the chassis bosses are another matter. The space between the boss and the wheel backing plate is not large and the space between the boss and the rear spring is not much larger. I looked at this configuration for about ten minutes and decided that there must be a special tool to remove these bushings. As usual, I called Ralph Curzon of Hyphen Repairs and, as usual, Ralph provided a solution. Ralph sent me the special tool shown in Figure 5. The cost of the tool was about \$50. The tool can be used to remove and install bushings in the chassis bosses as well as those in the shock pivot arms. I have labeled the cylindrical pieces in Figure 6; the stud is a 7/16" stud whose length is 4 and 5/16" long.

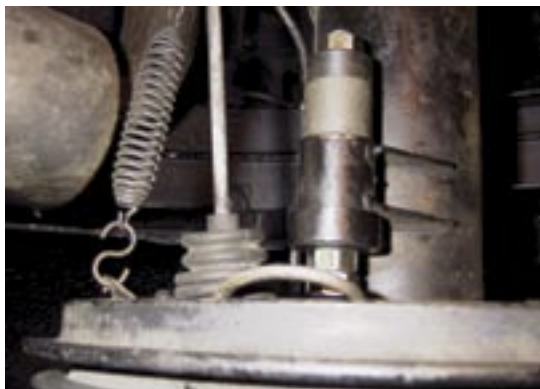
*figure 7*

To remove a bushing, the pieces are configured as shown in Figure 7. Part C is machined such that it fits over the inner steel cylinder and rubber of the Silentbloc bushing and yet is slightly smaller than the larger diameter of the bushing and hence piece C will pass through the hole in the chassis boss. Piece C is positioned next to the rear wheel and part B is positioned on the differential side of the boss. Part B is machined such that Silentbloc bushing can be pushed out of the boss and into the cavity of part B. Two nuts are used on the wheel side of the stud to lock the

nuts together on the stud. As the nut on the differential side is tightened, the stud advances and hence Part C and the bushing are pulled through the chassis boss and into the cavity of Part B.

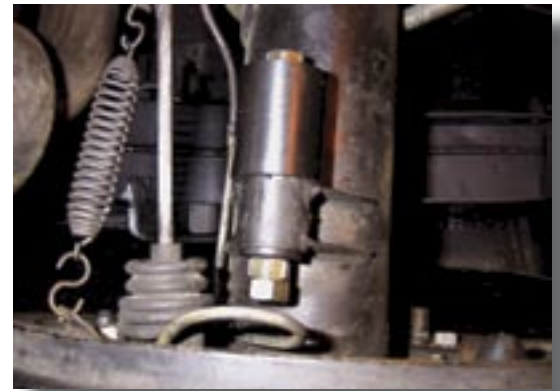
*figure 8*

To install a bushing, the pieces are configured as shown in Figure 8. In this case, Part A is positioned on the wheel side. Part A is machined such that as the bushing is pushed into the recess of part A, it will then bottom out on the recess. The recess depth is machined such that the bushing will be correctly (evenly) positioned lengthwise in the boss. The new Silentbloc bushing is on the differential side of the boss and now, as the nut on the differential side is tightened, Part C is used to push the new bushing into the boss.

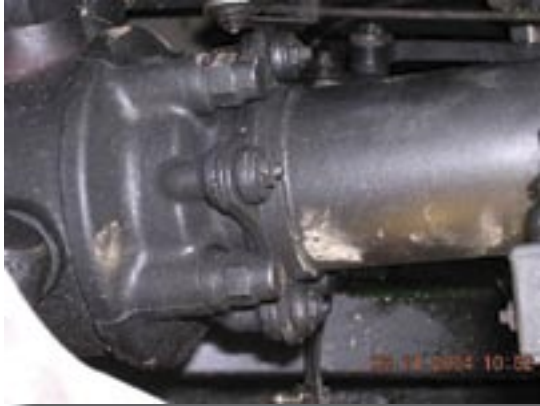
figure 1

If you own a Rolls-Royce Silver Cloud you probably have leaks from your power steering system in more than one location. Mine leaked from the ram, all of the hose connections and from the deadly steering box cover where the steering column connects. This is the most difficult to fix compared to the other leaks. This article is intended to give the reader a complete step by step procedure necessary to undertake correcting this particular leak. (figure 1) is where the leak is coming from.

This figure shows the bottom of the steering column connected to the steering box cover. The four small nuts hold the column to the box cover along with four double rubber washers that will need replacing. The four large nuts and four thick aluminum washers hold the cover on. At the base of the column on the under side (which cannot be seen) there is a vent hole and fluid is leaking from this vent hole. The cover contains a press in seal and about a five-inch "o" ring that is causing the leak. Okay, we now know the problem we are going to repair. You will need some zip lock bags and a marker to keep track of you parts as you remove them.

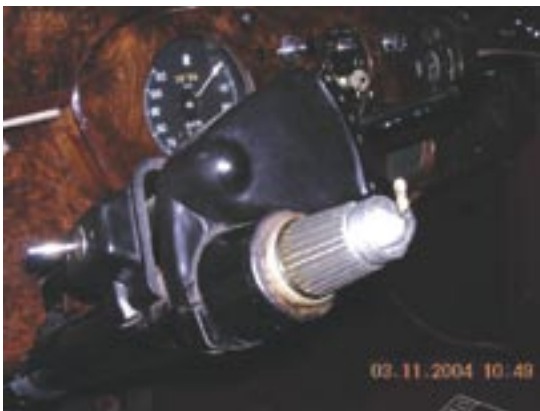
figure 2

Step 1: Remove the steering wheel. A previous article in the post 55 covered this procedure. However, I found getting the large nut off that holds the wheel on the column is not that easy. First remove the screws that hold the horn assembly on. There is a rubber connector on the horn wire that comes apart by unplugging the two ends of the wire. Now you can see the large nut, it is very shallow and a socket usually won't grab it. What I did was to drill an 8th inch drill bit hole through the nut half way between the threads and the outside edge then used a punch and hammer to drive the nut loose. Remember most of this stuff has never been touched for 40 or more years and requires some determination to loosen them!! Pulling the steering wheel also requires some finesse as not to crack the plastic. Figure 2 shows the steering wheel removed.

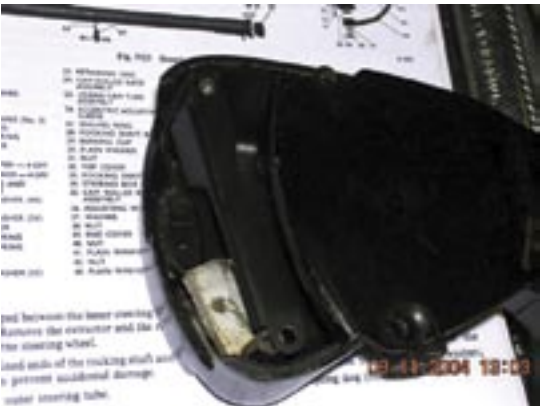
Step 2: Removing the shifting lever cover. Start by removing the shifting lever cover. See figure 3

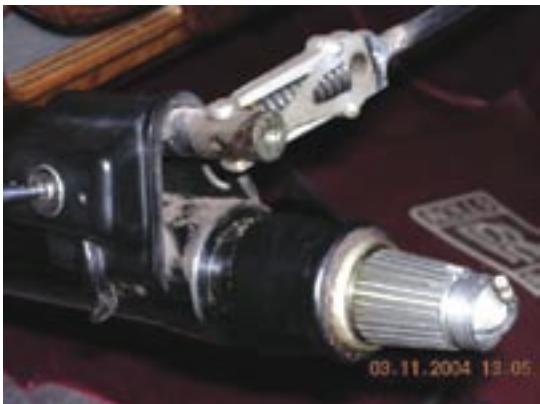
figure 4

Figure 4 shows the shift lever with the cover off.

Also, we will want to remove the dampener switch cover, behind the steering wheel, to disconnect the two wires connected to the switch. See figure 4.

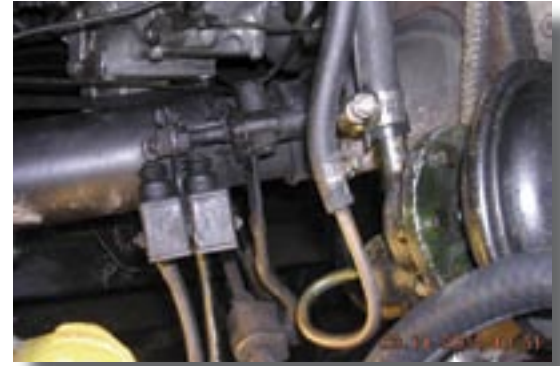
*figure 5*

Step 4. Next, get back to the shifting column, as it needs to be pulled completely from the car. As we can see in figure 5 there is a lot of pieces connected to the shifting column, but none of these parts are very difficult to remove as long as you remember how to refit them.

Step 5: Remove the linkage that connects to the transmission. Loosen the top bolt, in figure 5, and figure 6, until the linkage pulls off the shifting column arm. Make a note somewhere of the location of neutral on the transmission. When the shift column is out of the car you will have to later locate neutral by pushing or pulling the transmission arm. Also, be aware that there is a return spring connected to the arm with a clip. It is important when you remove it you will remember how it goes back on. If you have a digital camera take pictures to remind you later.

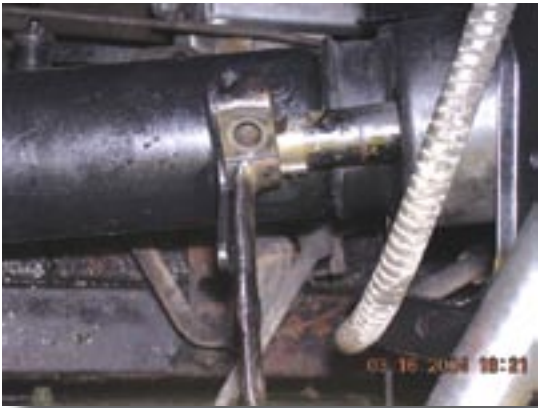
*figure 8*

Step 17. Putting the car back together. It's pretty much the reverse of our procedure. However, I did say there was an easy way to reconnect the shifting column shift arm that connects to the transmission! See figure 8; align the arm with the key lining up. Now rest the arm, as in figure 8 and tap the shift column from inside the car with a hammer until the arm is all the way on!! Also, remember the duct has to go in before the shift column. Guess who installed the shift column first!!!

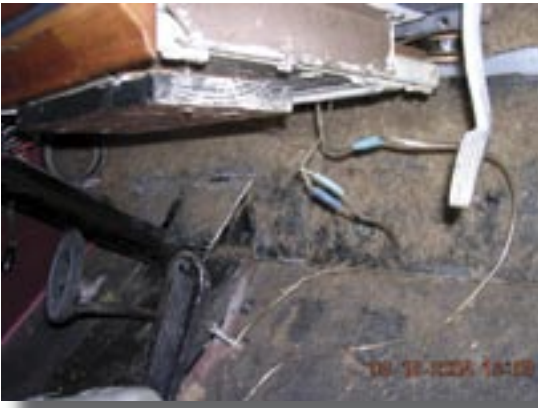
*figure 9*

Step 8. Removing all the stuff inside the car that's in the way!! It's messy, but when you are done, it will be okay! Start by removing the floor mats and carpet up front. Also, remove the front seat, the part you sit on not the backrests. This will just pull up and out. Now you can pick up all the spare change that fell behind the seat! Next remove the slide out tray under the dash; this will have four screws holding it in. We need to make room, as you will be lying on the front floor to complete this job. You also have carpet glued up on the firewall; you will need to pull this out. This will be messy and you will need to purchase some jute pad and spray glue to put this back together. This piece of carpet should be about 8 inches high and the width of the car. See figure 9.

Step 9 . Removing the firewall cover. This piece is about 10 inches high and the width of the car.. See figure 9. This is held in place with many pan head screws. Some will come out easily and others will probably cause swearing. But that's okay, I invented many words never heard before while taking this cover out!!! This is where your impact driver will come in handy. Others, you may have to drill out, center punch first, and then drill them out. It doesn't matter, you can always drill and screw a couple of sheet metal screws to refit it. Also, you may notice, in figure 9, I tried to cheat by cutting out a section behind the steering column, it didn't work! The reason this cover has to come out is so we can take up the floor pan, which is the next step.

Step 10. Removing the floor pan. Figure 9 shows the floor pan, however not clearly! The floor pan is composed of two parts, the small pan around the brake pedal and the larger pan that surrounds the steering column. Start getting ready to remove the brake pedal, pad and arm. See figure 14.

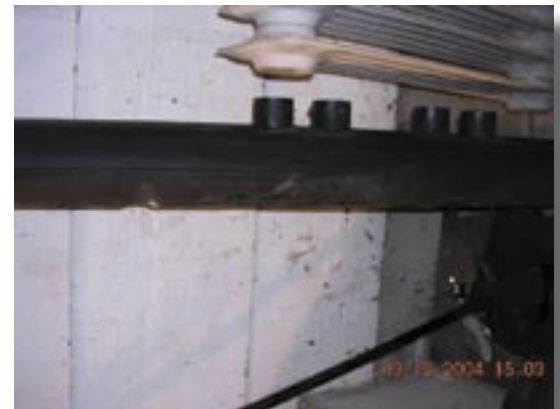
*Figure 12*

Remember, you must refit the duct before replacing the shift column or the duct will not go back in place, see figure 12.

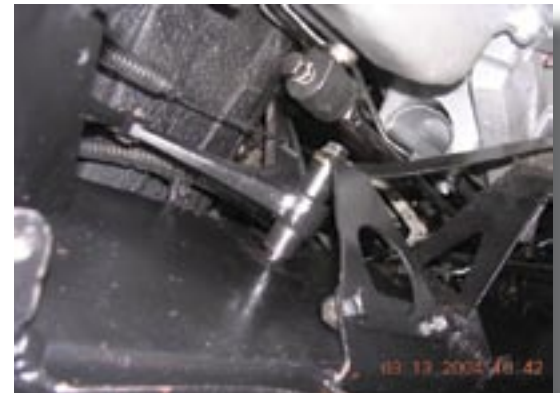
*figure 13*

In figure 13 you can see a bracket with three bolts, one of these bolts is the pivot point for the brake pedal. Follow the arm up the picture and at the top is where the brake pedal and arm connect. Although, it cannot be seen clearly in the picture, there is a bolt connecting the pedal arm to the pivot arm. Loosen the bolt and then twist the pedal back and forth from within the car and it will pull out of the floor. Next remove all the pan head screws holding the large floor pan, not the smaller brake pan. Next go back into the engine compartment (sorry no picture). Where the steering column goes through the firewall there is a rubber boot and surrounding metal. About 8 screws hold this in place; remove them. Hopefully, the floor pan and firewall boot assembly is loose and free now! See figure 14.

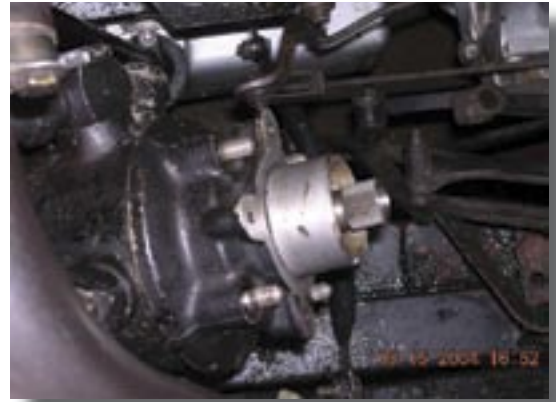
Step 13. Removing the four fingered dog. See figure 18. In the center of the dog is a thick washer and a bolt. Loosen them up. Then attach a gear puller as shown in figure 18. When the dog pops loose then remove the center bolt and washer and remove the dog from the splined shaft. Also notice, in figure 18 there is a hard rubber sleeve slipped on the end of the housing. Remove it. (I thought it was metal and almost broke it) Your housing should look like figure 19 now.

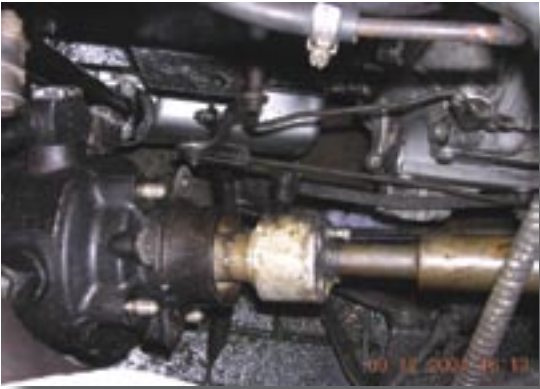
figure 16

Step 12. Removing the steering shaft. See figure 16. The steering shaft is connected through a rubber coupling held on by four bolts. Figure 16. Remove the four bolts and pull the shaft free from the rubber coupling. It should just pull out, however if it is stubborn, I have a method to free it!! Take your steering wheel and put it back on the shaft loosely. Now, take the large nut and tighten it a couple of turns. What we are creating is a slam hammer. By pulling the steering wheel toward us in a slamming type action. This slamming action should free up the shaft very quickly. Take a look inside the rubber coupling to determine whether or not it requires replacing (mine was okay). See figure 17.

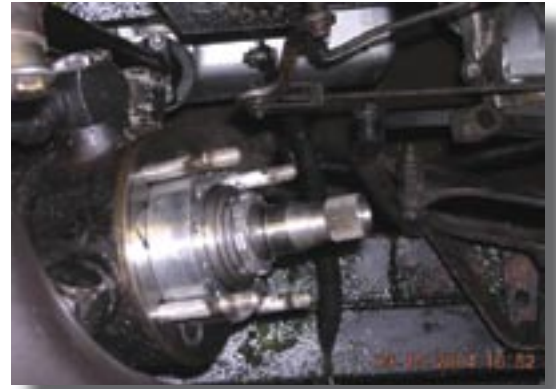
figure 20

Step 14. Remove the housing cover. Start by removing the four nuts and thick aluminum washers. Make sure the washers face the same side out as removed when refitting! See figure 20. When the cover is removed it will look like this.

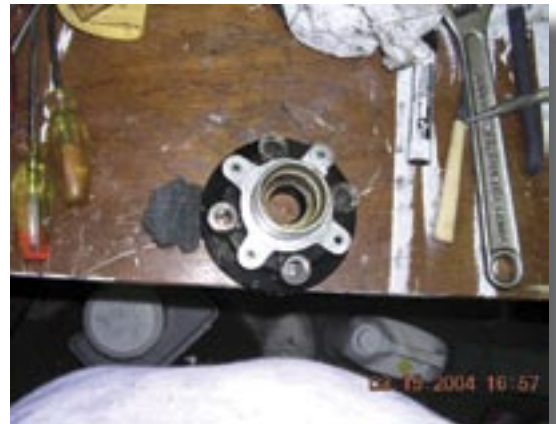
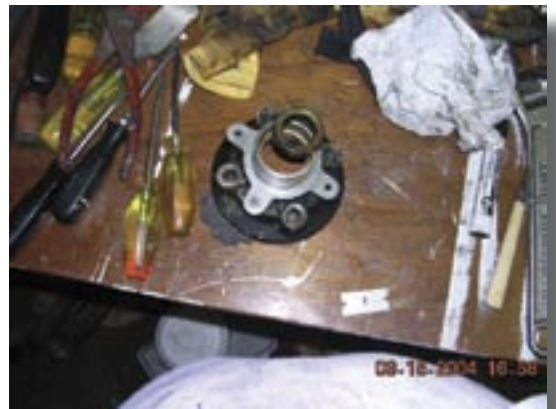
figure 21

Step 15. Replacing the seals. As I said earlier, there is a press in seal and a very large "o" ring. Start by cleaning out all the old "o" ring remains; it must be very clean to work! Now, remove the seal by tapping it out using a socket of the same size. See figures 21 and 22.

Now replace the seal by tapping it in with a socket. Make sure the seal is facing the same direction as the one removed. The "o" ring has a tendency to jump the groove when installing. After the seal and "o" ring are installed, slide the cover back on the housing. Be very careful the "o" ring stays in place. Now, install the four aluminum washers, with the correct side out, and nuts on the cover. Tighten these nuts, but not too tight as I do not know the correct torque specs! We will start the car and engage the power steering pump to inspect for leaks, before refitting the remaining parts. This is where it's important you know where neutral is. We will be bypassing the neutral safety switch and do not want to run over ourselves, do we!! Now install the new sleeve you ordered. Install the dog with its washer and bolt.

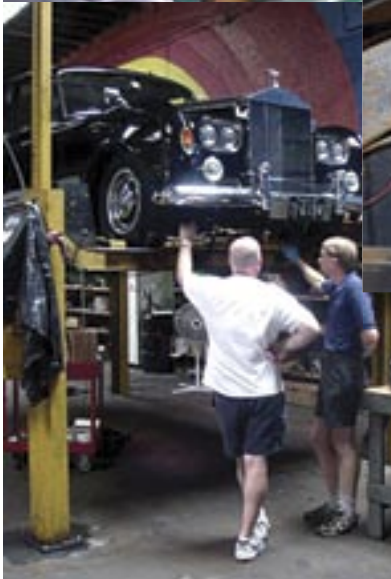
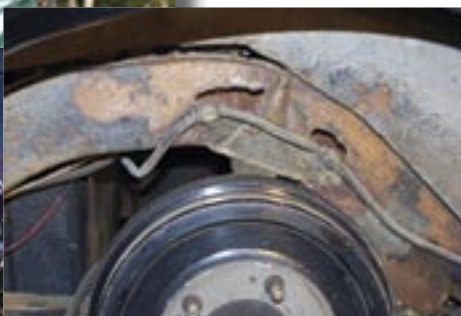
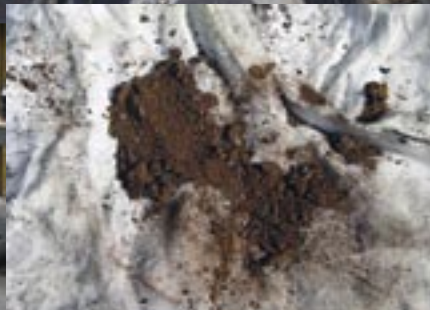
With the help of Tim Myrick and Bill Habacker (both TX) we began to clean the surface rust of her frame and re-coated her with a few coats of Eastwood’s rust inhibiting primer and gave her a new coat of paint. This sanding and grinding revealed a

large patch on the frame, behind the right-rear wheel, where the rust had actually rotted away part of the frame (see photo). Well, why not, let’s get her ready for the National Meet, and begin a full restoration following our trip to Newport.
