# Post55

Autumn 2004

# Taking a Look At Your Foglamps

By Larry Durocher (LSCX671)

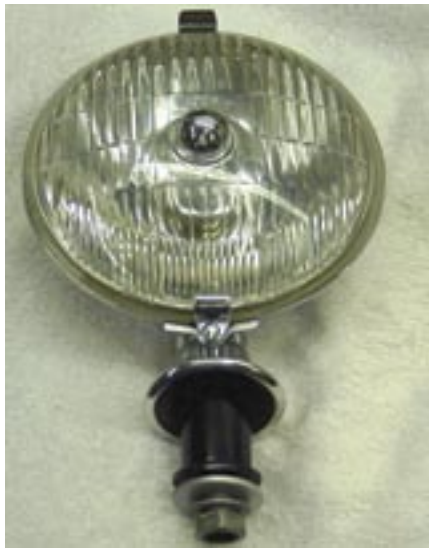
figure 1

- Remove the bottom screw/clamp (see Figure 1), holding the glass lens in place with your hand.

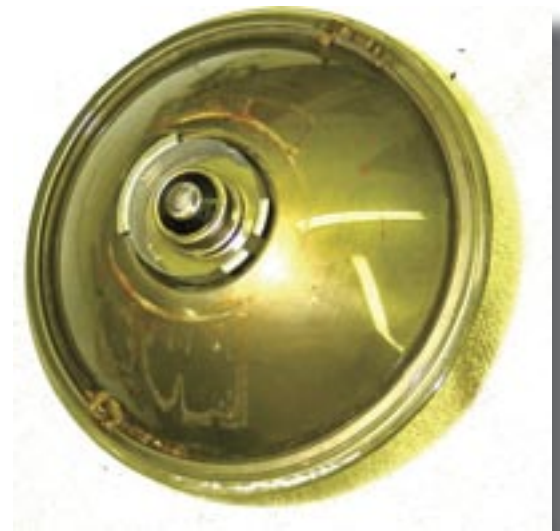
figure 3

The bulb holder is removed by simply turning anti-clockwise. With the bulb holder removed, we see the bulb itself resting in the reflector housing.

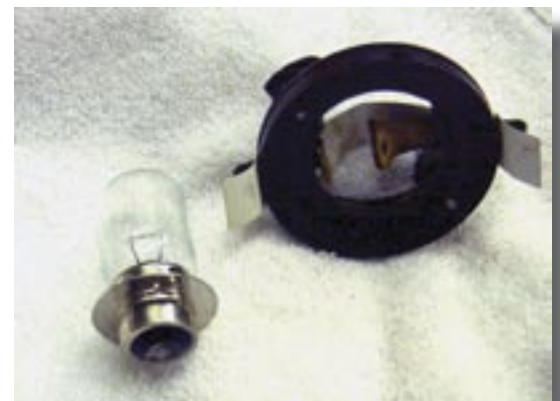
figure 4

The bulb and the bottom of the bulb holder are shown in Figure 4.

The overall conduction path can now be visualized. Current comes in via the bullet/cylindrical connection (on right in Figure 4), through the copper strip (on right), to the center contact on the bulb, through the annular face of the bulb body to the reflector housing, from the reflector housing to the other copper strip (on left in Figure 4), out of bullet/cylindrical connection (on left) and finally to some common ground located elsewhere. We do not need to worry about the fog lamp housing being grounded, the two wires supply current in and a path to ground.

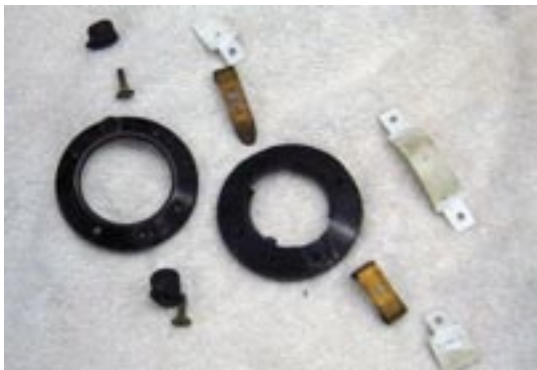
figure 5

I decided to disassemble the bulb holder to see if there was anything else of interest. The parts are shown in Figure 5. The bulb holder is composed of two main circular pieces, the copper strips are sandwiched between the two pieces, two screws bolt the assembly together and three plastic strips and two rubber "grommets" provide insulation against incidental contact

Although it may not be clear from the pictures, the bottom circular piece has two bosses and each copper strip rests in a radial cutout in the plastic. Each of the copper strips has a hole and the bosses hold the copper strips in position. If the bosses are broken, only the clamping pressure (caused by the screws) holds the strips at the proper radial location and prevents the strips from shifting slightly in the cutouts. I found that one of the bosses on my bulb holder was broken (actually snapped off and missing) and hence the associated copper strip was not firmly held in place. I happened to have a spare bulb holder so I didn't have to fix the piece. A number of fix options come to mind, such as super gluing a new boss in place, gluing the copper strip to the plastic piece, drilling the plastic and creating a new metal post/boss from a screw, etc.

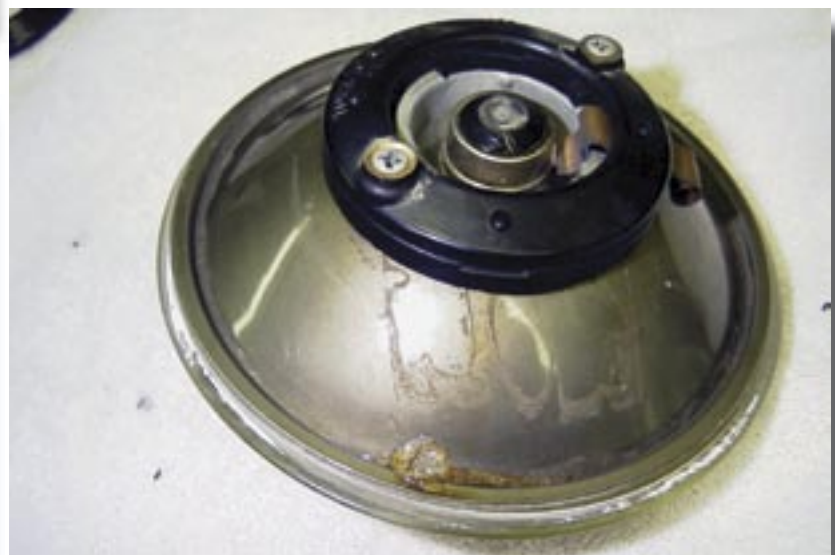
figure 6

The last one has the potential to be a frequent source of problems. Good contact requires the copper strip to exert high pressure at the contact and the shape of the strip provides line contact at most, see Figure 6. I have removed the other copper strip and the plastic insulators to make the contact between the copper strip and the reflector housing more visible.

- Used solder to build up (see Figure 7) the contact surface on the copper strip (see Figure 6) that rubs on the reflector housing.

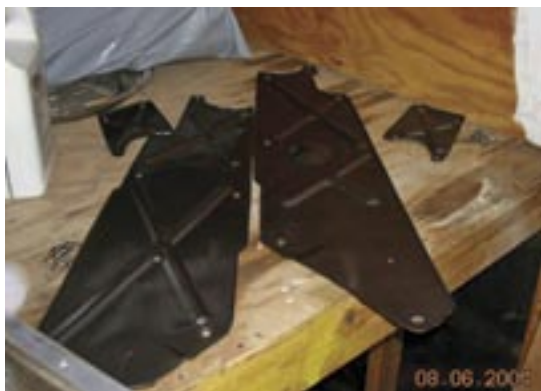
figure 1

Step 2: Disconnect the battery cable and remove the belly pans. See figure 1.

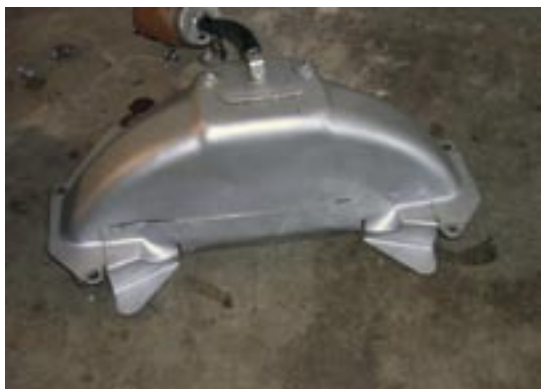
figure 2

Step 3: Remove the fluid coupler cover, clean and repaint with Krylon dull aluminum paint\*, see figure 2.

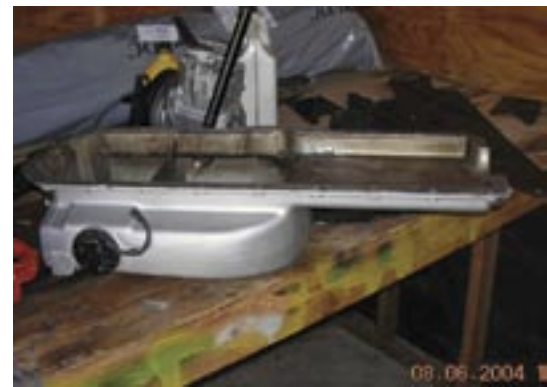
figure 3

Step 6: Clean your pan with solvent and check for metal in the sludge. Also, this is a good time to check out your oil level sender. It's basically a rheostat and is quite reliable. If it doesn't work it may be the grounding that's off! See figure 3.

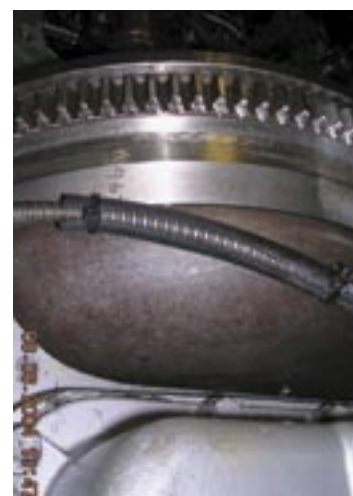
figure 5

Step 8: Check your starter ring gear for chipped or damaged teeth. I took a mini grinder to mine and cleaned it up. Damage or wear is usually caused by a misaligned starter drive!! See figure 5.

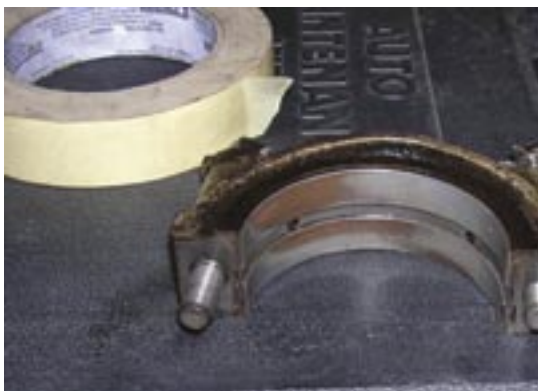
*figure 6*

Step 11: Check your bearings for wear. I recommend pulling off cap number 6 and checking the cap bearing for wear. This is the one that usually shows wear by copper showing. See figure 6. Typically, the bearing in the cap will show more wear than the upper crank bearing! Also, remember the direction of the cap and see that the bearing notches line up or oppose each other. For those who are not aware of bearing notches, they are at one end of each bearing shell and both the cap and the block have indentations that these notches match up with. The purpose is to prevent bearing from spinning!

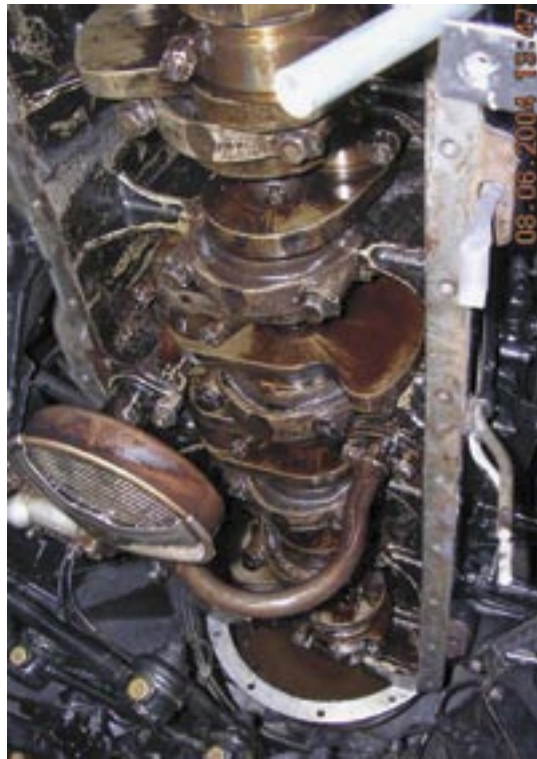
*figure 7*

recommended to replace your thrust washers located at the center bearing under the oil pump. See figure 7. We will move forward with the assumption you plan to replace all main bearings and thrust washers.

Step 22: The center bearing is under the oil pump. See figure 7. Do not remove the oil pump; you can do this with the pump in place. One of the bolts will not drop out but will come out with the cap. The other will drop out, so remember it when reinstalling the cap. Rock this cap back and forth to loosen and it should come out with the torque washers attached to both sides. There will be grooves on the outside of the washers and the new ones must be installed the same way. Clean the cap and install a new bearing and torque washers using assembly lube. Roll out the upper torque washers first, they are loose and should come right out. Next, using the same method, remove the upper shell and install a new one. Now roll in two new thrust washer with grooves facing out and install the cap. Again, leave it loose until all bearings are replaced.

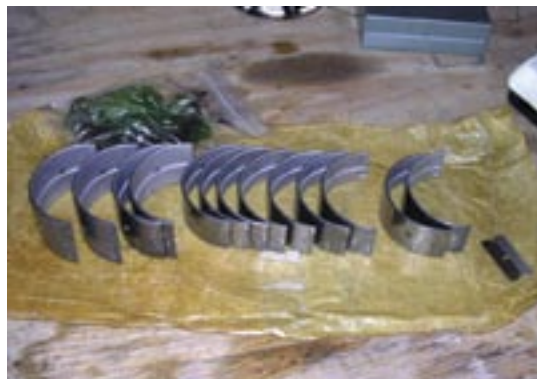
*figure 8*

Step 15: Purchase new main bearings and thrust washers. See figure 8. First, you need to know if the bearings you removed are standard or oversized. If they are standard then you must replace with standard size. Do not attempt to replace with

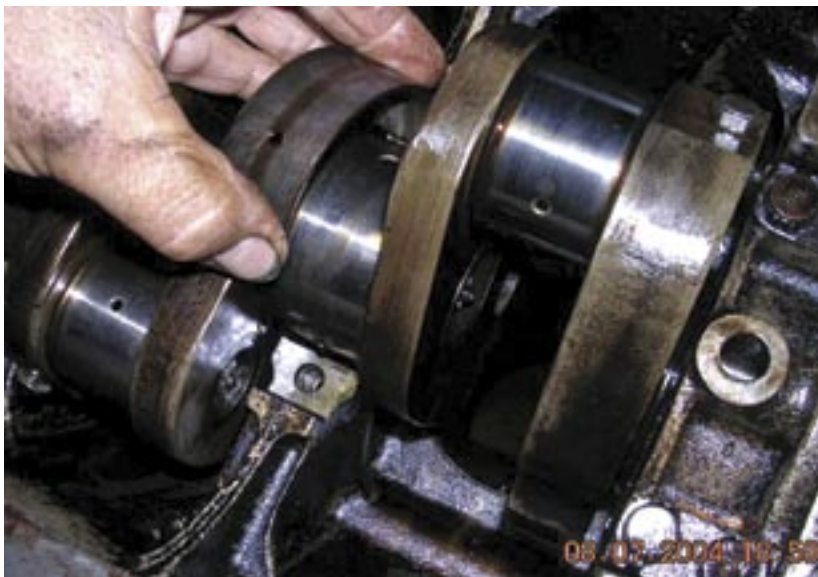
*figure 9*

Step 19: Remove number 1 bearing cap and identify on the upper bearing which end has the notch. On the other end of the bearing, carefully take a screwdriver and tap that end of the bearing to roll it out. See figure 9. It should begin to move unless there is a significant amount of pressure against the upper bearing. Now take a flexible piece of metal strip that has no sharp edges and follow the bearing around and out by turning the crank at the same time. For this you must remove the spark plugs. There is a tool available that will turn the engine by hooking on to the starter gear! See figure 5.

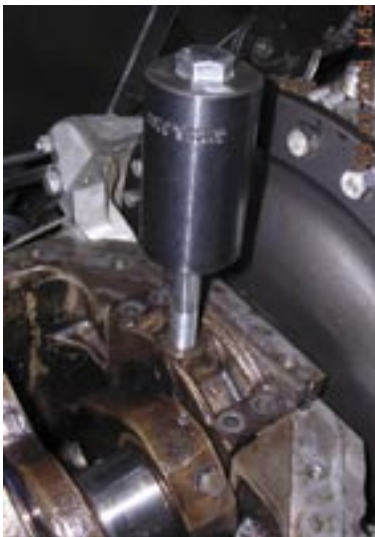
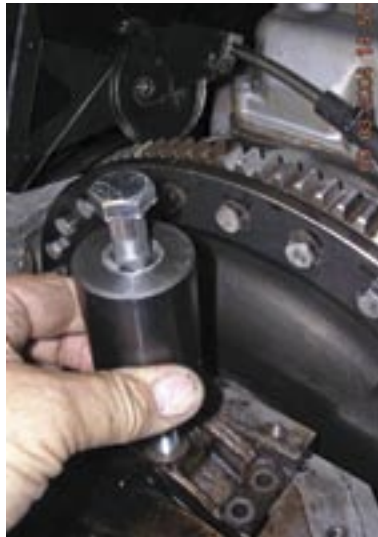
Step 23: Remove the number 7 cap. The number 7 cap can only go in one way as it is on a track and must be pulled out straight. See figure 14. The method I devised uses a long seven inch long bolt that threads into the center of the cap and a heavy impact socket as a slide hammer. As figures 10 and 11 show, I tap downward with the socket while keeping the cap straight. When

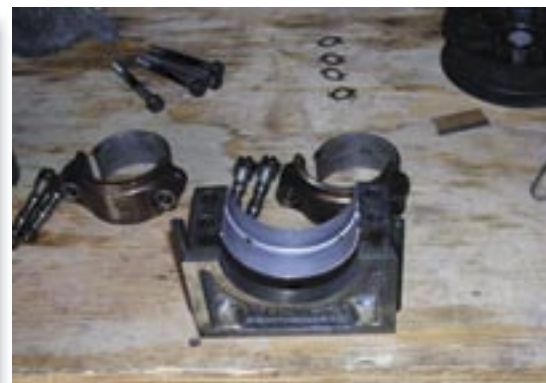
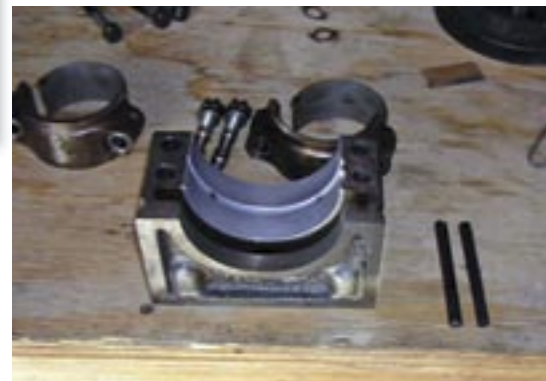
the cap comes out you will find two wooden dowels grooved into the sides of the cap. See figure 12 and 13. This is to keep oil from leaking around the cap. These dowels can be ordered from a dealer. Also, with the cap removed, you will notice there are no rear seals other than the dowels. If you look closely you will see grooves that are reverse threads that direct oil back into the pan so that oil cannot leak out. After reinstalling the new cap and bearing shells with lock washers you install these dowels. Check to see the dowel holes are lined up to prevent destroying the dowels. Coat the new dowels with assembly lube. Using a hammer, gently tap the new dowels into the installed cap. Be careful to drive them in straight so the dowels don't break. After they bottom out, take a hack saw blade and cut them off at the base. Then use a razor blade to make sure they are flush with the surface.
