## Detroit (Trunnion) bearing boot installation/removal tool

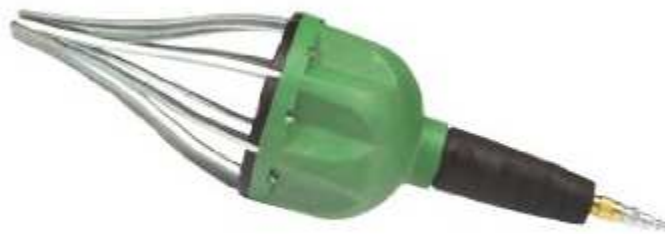
Dorman 614-030 Universal Fit CV Boot Air

The purpose of removing 4 of the arms has two purposes first it minimize the amount of expansion needed and second is so the unit after the boot is expanded can be placed around one side of the trunnion pin and pushed over the other side without the arms getting in the way. Simple, it uses 95 to 98 psi of compressed air. The expansion rate is controlled and has proven to be a safer process than using long screwdrivers etc. and one can do it by hand without the use of a large vice.

I have been looking for a tool that does not require so much labor, is less stressful on the rubber boot and does not require a massive shop press. The boot can stretch a lot without harm so that is not a major issue; it is the use of tools that may produce an excessive amount of stress in a small area or that may have sharp edges that can cut or scratch the rubber shortening the boot long life. The "Dorman 614-030 Universal Fit CV Boot Air Tool" made by UNI-FIT division of R&B, inc. (a USA company) with modifications is almost a perfect tool for this job, and it's easily obtained (for example it's sold on Amazon) for about \$130. The tool cost about the same as one of the UG11121 Detroit pot sealing boots and well worth the cost if it saves the life of a single boot. The modifications are simple; just remove every other arm on the unit making the unit a 4 arm instead of 8 arm device. The removal and reinstallation (reinstallation of the arms is only needed if the unit will be used for a CV boots also) of the arms is easy, just loosen the frame screws no need to disassemble the unit. For commercial use the air driven expansion cone inside the unit will need a steel reinforcement cover to increase its durability. Using air pressure the boot can be safely and easily be expanded so it

will slide over the trunnion pin. No real need for lubrication and only a small round guide bar to assist the boot over the pin may be needed.
