Many of our members may not be aware of what happens when a cam drive belt lets go - the following photos are from a recent failure on my 4WD diesel engine due to a diesel engine service centre not taking due care when reinstalling a drive belt after overhauling the fuel injection pump. The major damage included a broken camshaft, 6 bent valves, 6 bent/indented adjusting shims and fortunately only one piston crown indented from hitting a valve which did not require replacement. The belt broke at a speed of 110Km/hr [70mph] about 120Km [75 miles] from home at 8pm necessitating a trip home on the back of a flat-top truck after a 2 hour wait for it to come from Taree.

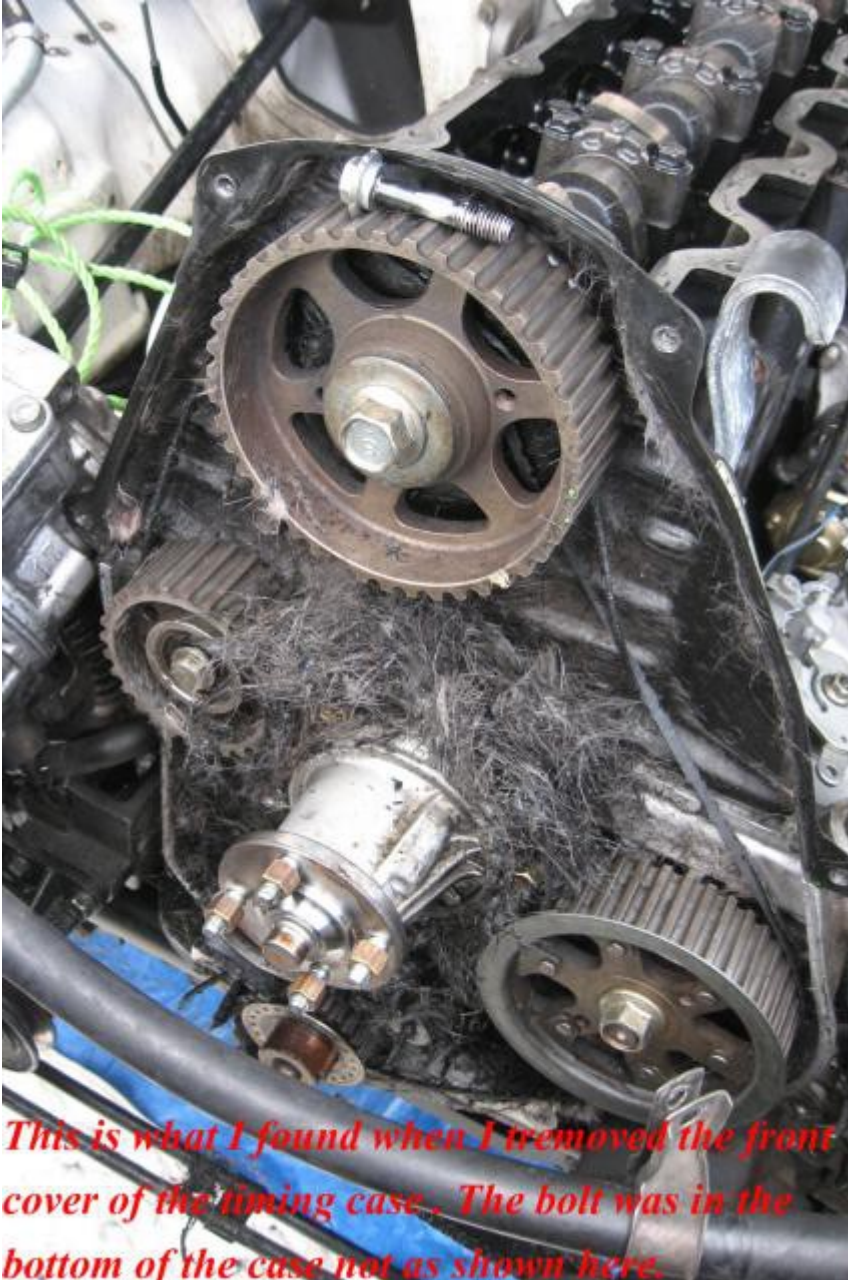
This is what I found when I removed the front cover of the timing case. The bolt was in the bottom of the case not as shown here.
